U.S. Department of the Interior  
Bureau of Land Management

# AQUATIC HABITAT MANAGEMENT PROGRAM

2019 UTAH ACCOMPLISHMENT REPORTING

## **Aquatic Habitat Management Program 2019 Utah Accomplishment Reporting**

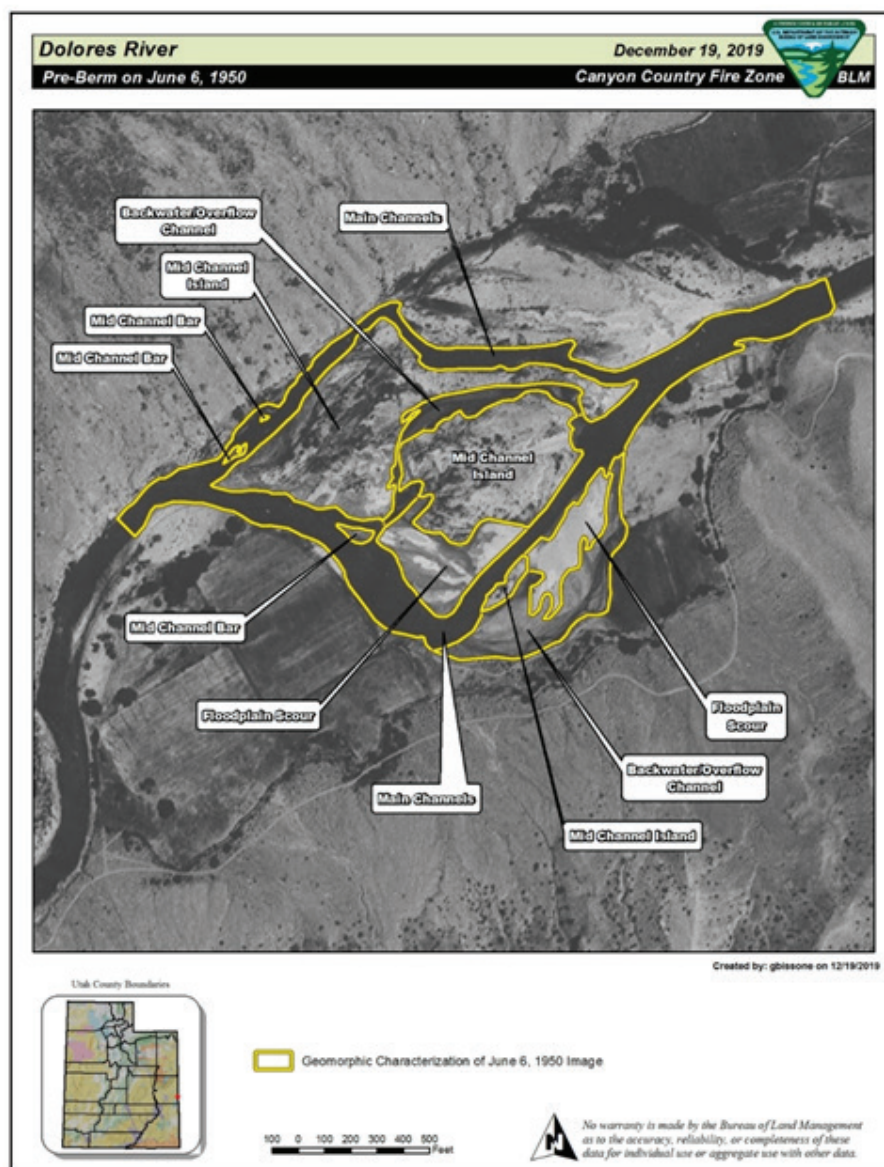
Figure 1. Pre-berm river geomorphology in 1950.

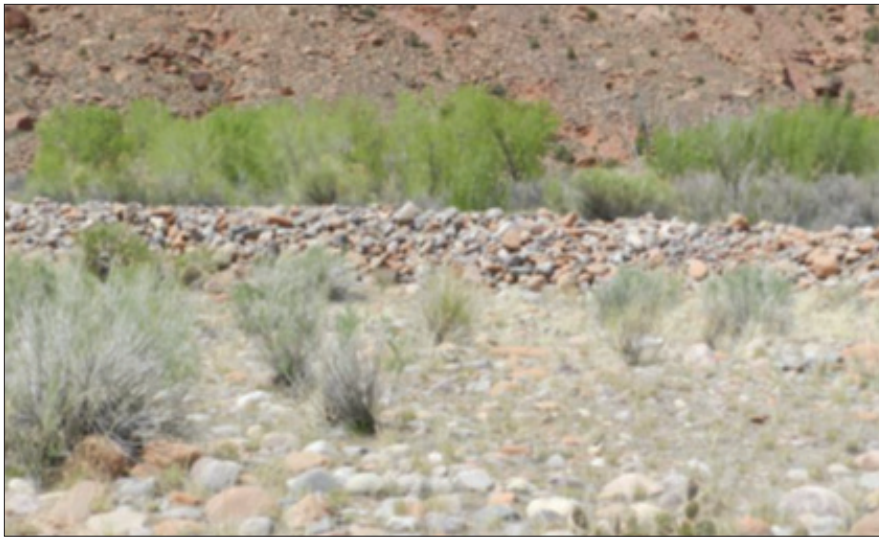
This berm has persisted over the years dramatically changing the hydrology of the 38-acre site (Figure 3) and diminishing nursery habitat for native fish. Historically, the Dolores River would convey large flood discharges in the spring, with a high discharge of 17,000 cfs measured in the 1970's. In the 1980's, McPhee Dam was constructed upstream in the watershed, significantly reducing historical peak flood flows.

There is little evidence this historic channel and associated floodplain has been inundated during high flows since McPhee Dam was constructed.

Figure 2 – Historic gravel/cobble berm.

The Environmental Assessment for the berm removal was part of a larger project effort lead by the BLM Grand Junction Field Office in collaboration with the Moab Field Office Hydrology staff. In February 2019, a portion of the gravel/cobble berm was successfully removed at the upstream end using heavy equipment over the course of 4 days. Peak 2019 flows (~5,000-6,000 cfs) reestablished hydrologic connectivity of the historic channel, floodplain, and wetland habitat at the contemporary bankfull discharge, for the first time in 50-60 years (Figures 4 and 5). This marks the beginning of periodic inundation of this area which transitions from a lotic system to a lentic pond as flows recede.

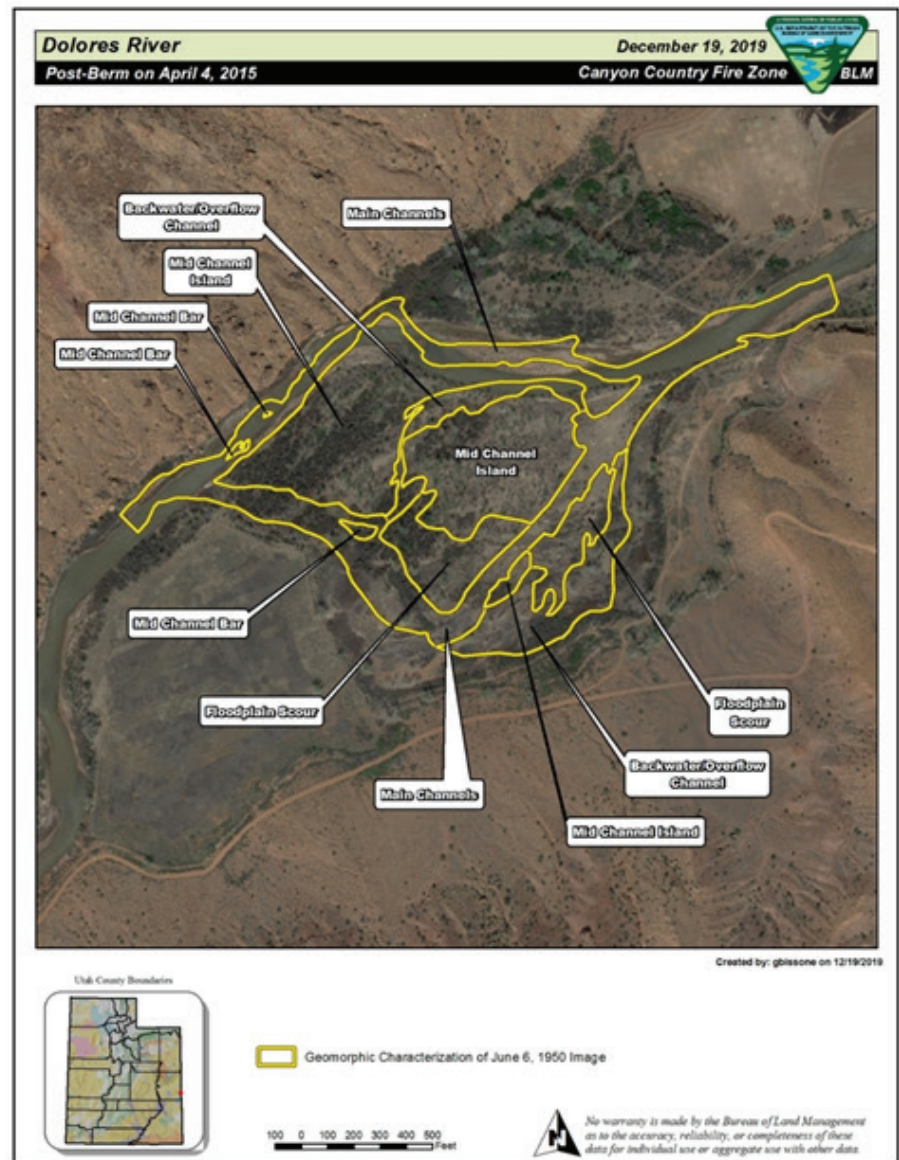
Figure 3. Post-Berm River in 2015 with pre-berm features overlain.

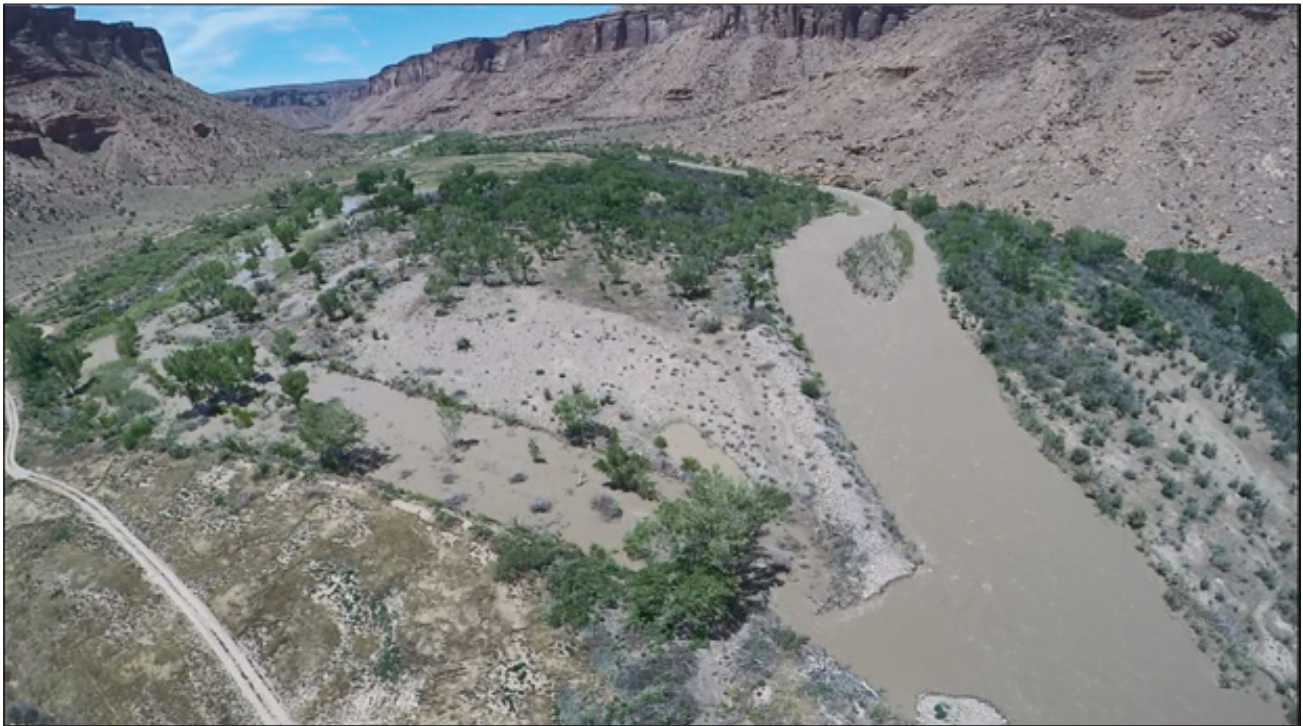
*Figure 4. Inundation on June 17, 2019 at ~5400 cfs at upstream berm removal area.*

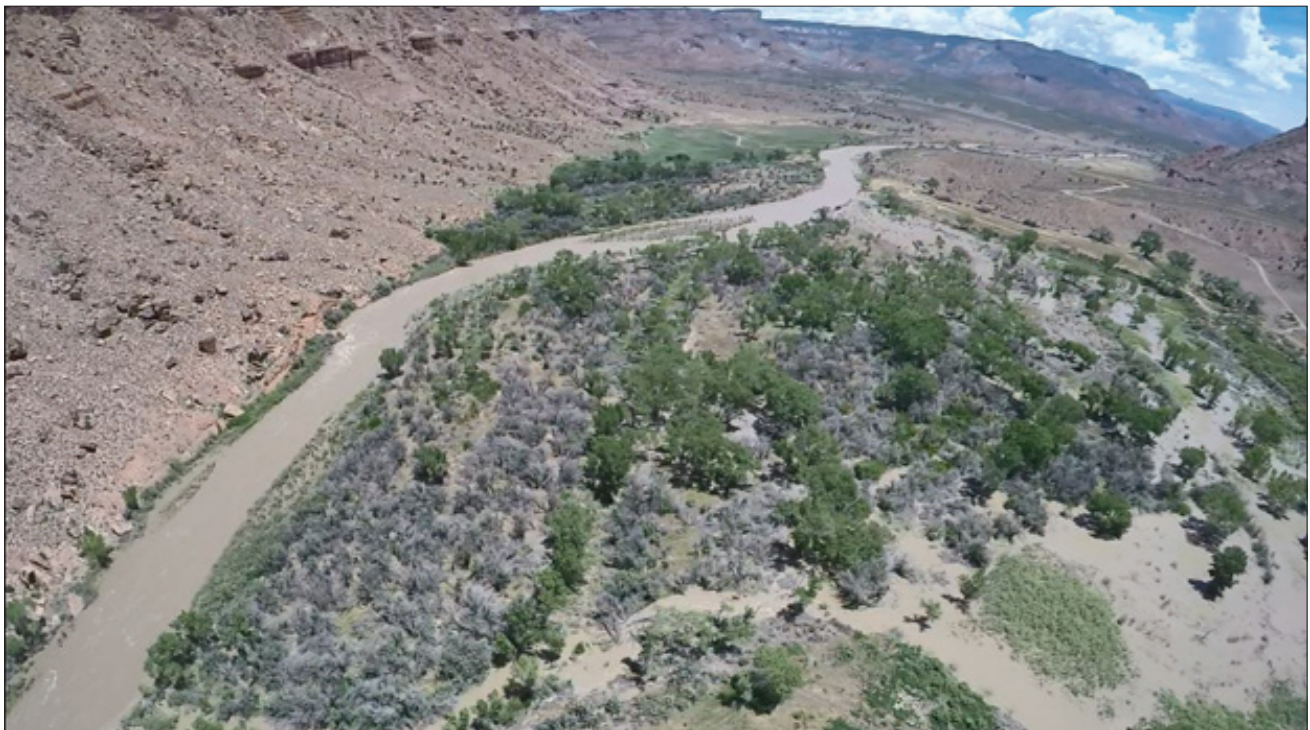
*Figure 5. Inundation on June 17, 2019 at ~5400 cfs at downstream end looking upstream.*

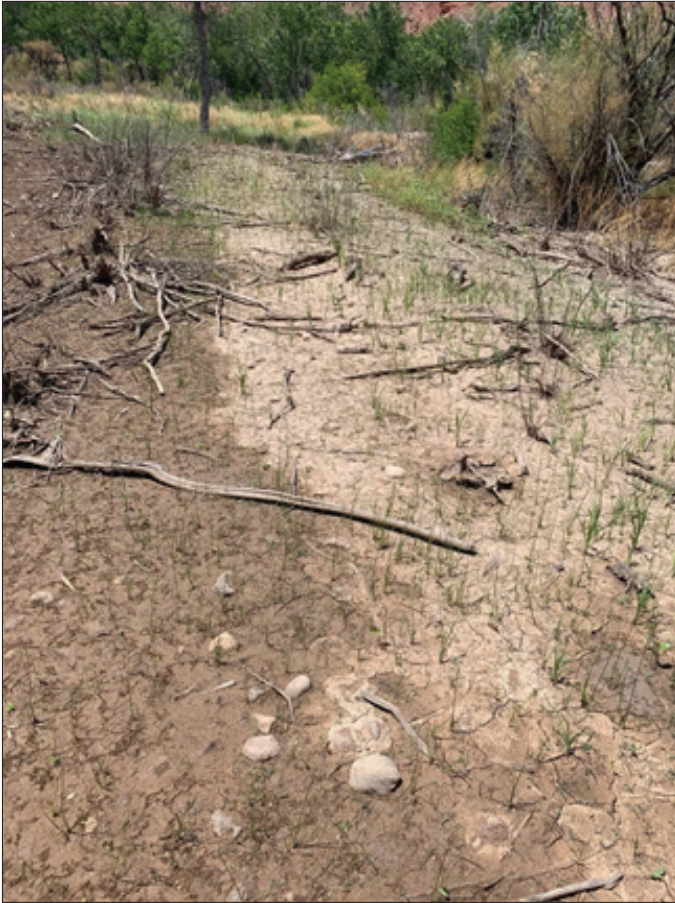
water cycling, plant and animal production and hydrologic connectivity. Sedges, rushes, and cottonwood seedlings have begun to colonize the site (Figures 6 and 7). The perennial wetland area was inundated by surface waters (Figure 8). Fine sediments are being removed at the downstream-end exposing cobble and gravel channel substrates improving aquatic habitat for macroinvertebrates and fish (Figure 9).

*Figure 6. New sedge and rush colonization.*

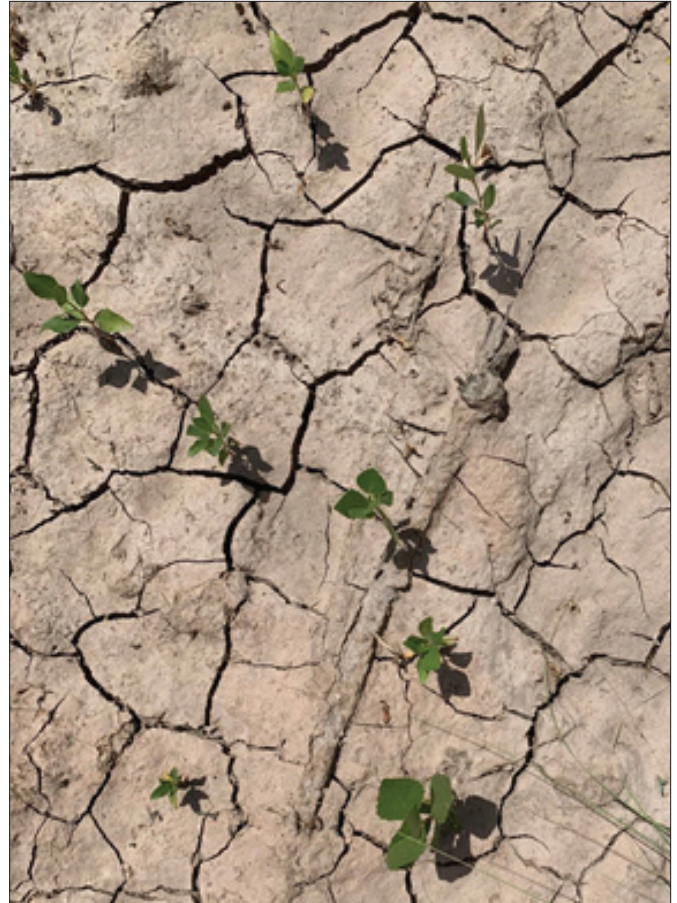
*Figure 7. New cottonwood seedlings.*

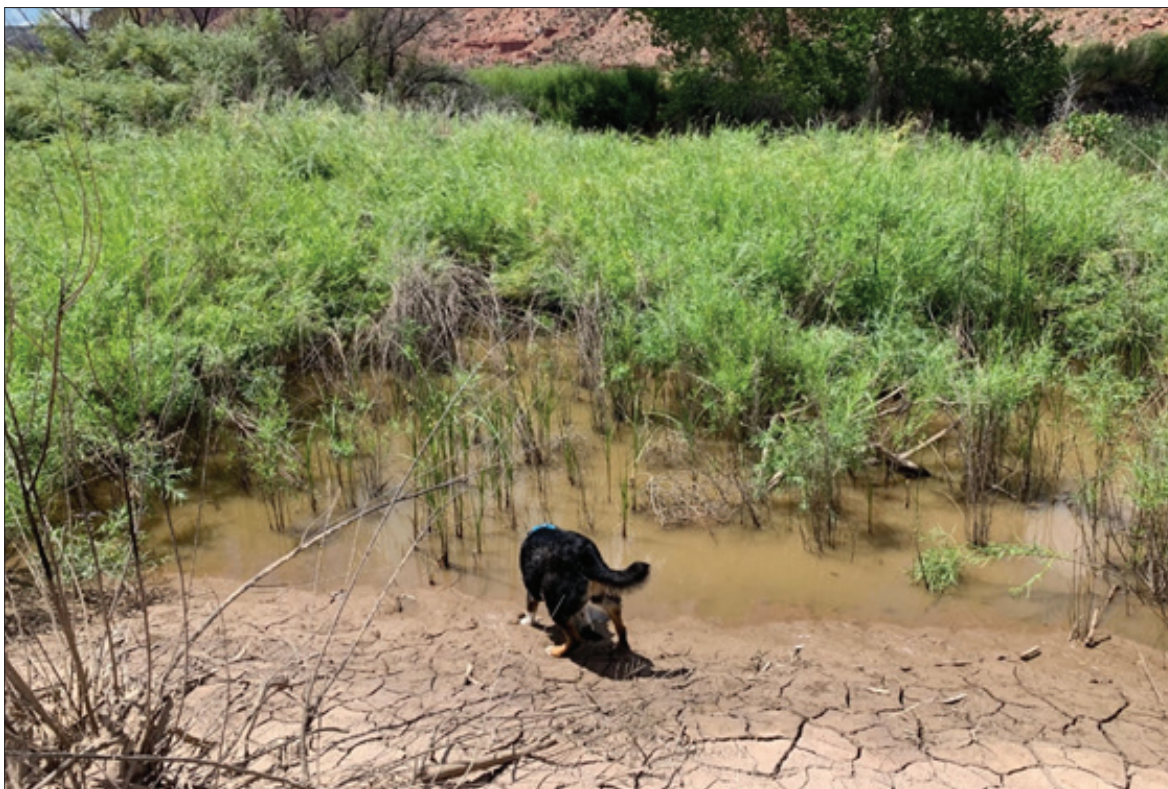
Figure 8. Inundated wetland area resulting from reestablishment of hydrologic connectivity.

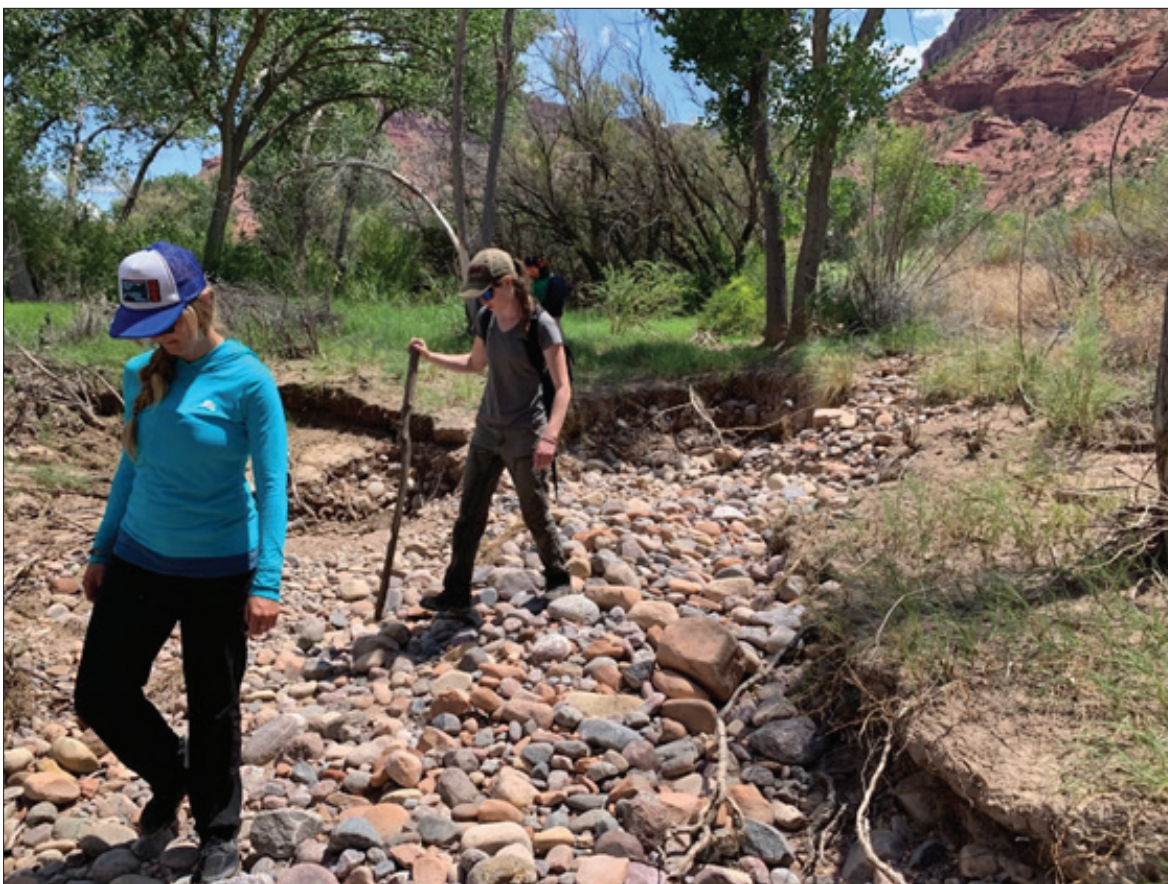
Figure 9. Cleaning fine sediments and exposing gravel and cobble substrates noticed during WRI project planning site visit with partners from the Western Conservation Corps, Canyon Country Youth Corps, and the Dolores River Restoration Partnership.

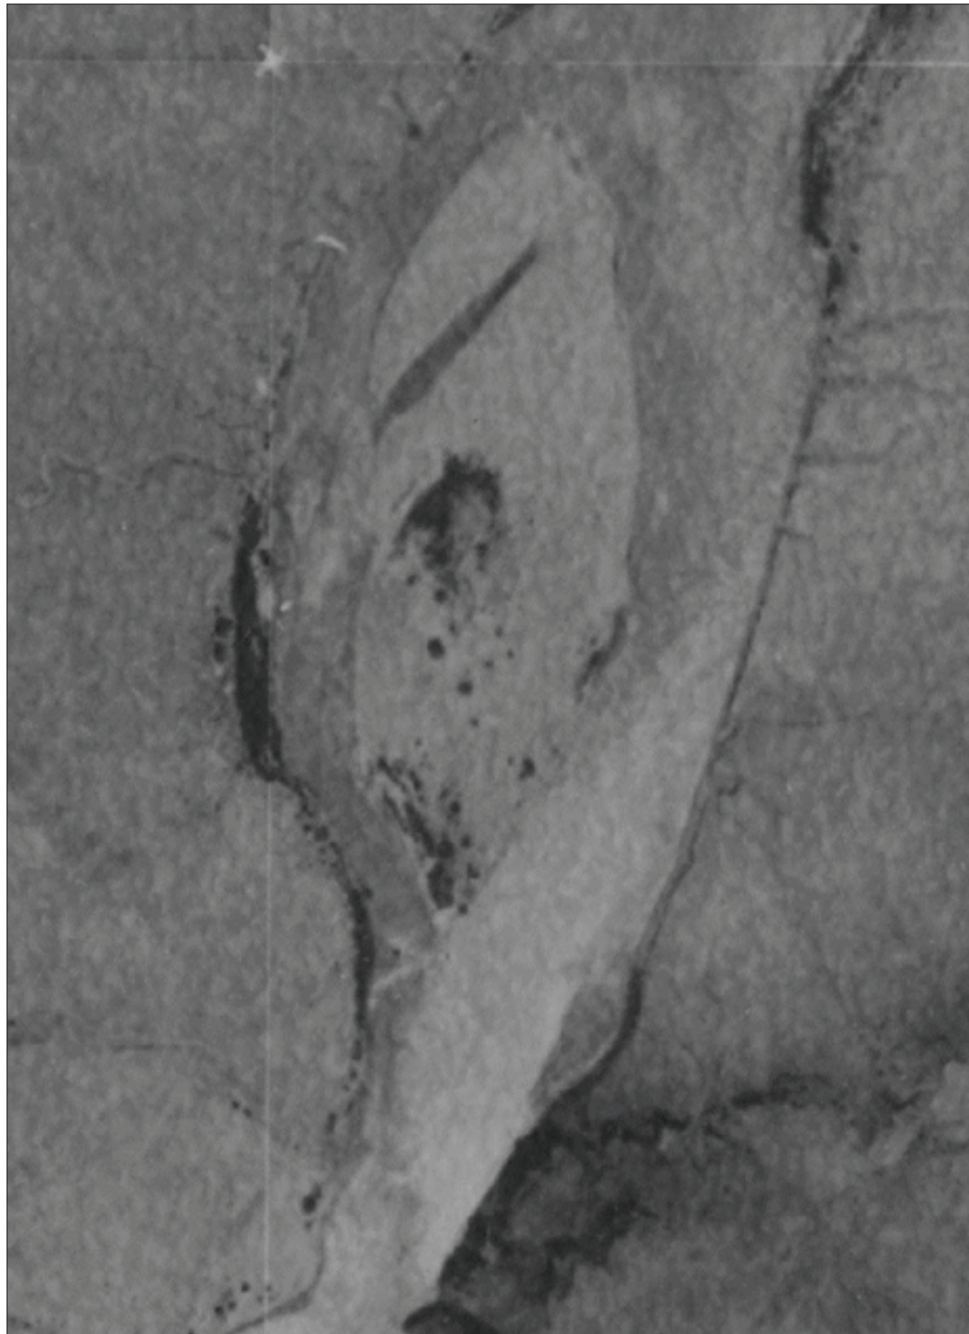
This project area was historically a mid-channel island with perennial flow in both the main and side channel and was characterized by little vegetation in 1937 (Figure 10). Tamarisk has since invaded the island and in the absence of scouring flow events has become well established (Figure 11). Woody invasive species create roughness in these channels that slows water velocity and causes sediment to deposit and fill in the channel. Today the primary side channel has significantly narrowed (Figure 11) and is only seasonally inundated during very high water events like 2011. This encroachment also decreases the native vegetation's rate of succession and degrades wildlife habitat. Additionally this stand of tamarisk has succumbed to the defoliation effects of the tamarisk leaf beetle, which increases the risk of wildfire adjacent to a popular lunch stop for rafters.

Figure 10. Above New Rapid Side Channel in July 15, 1937.

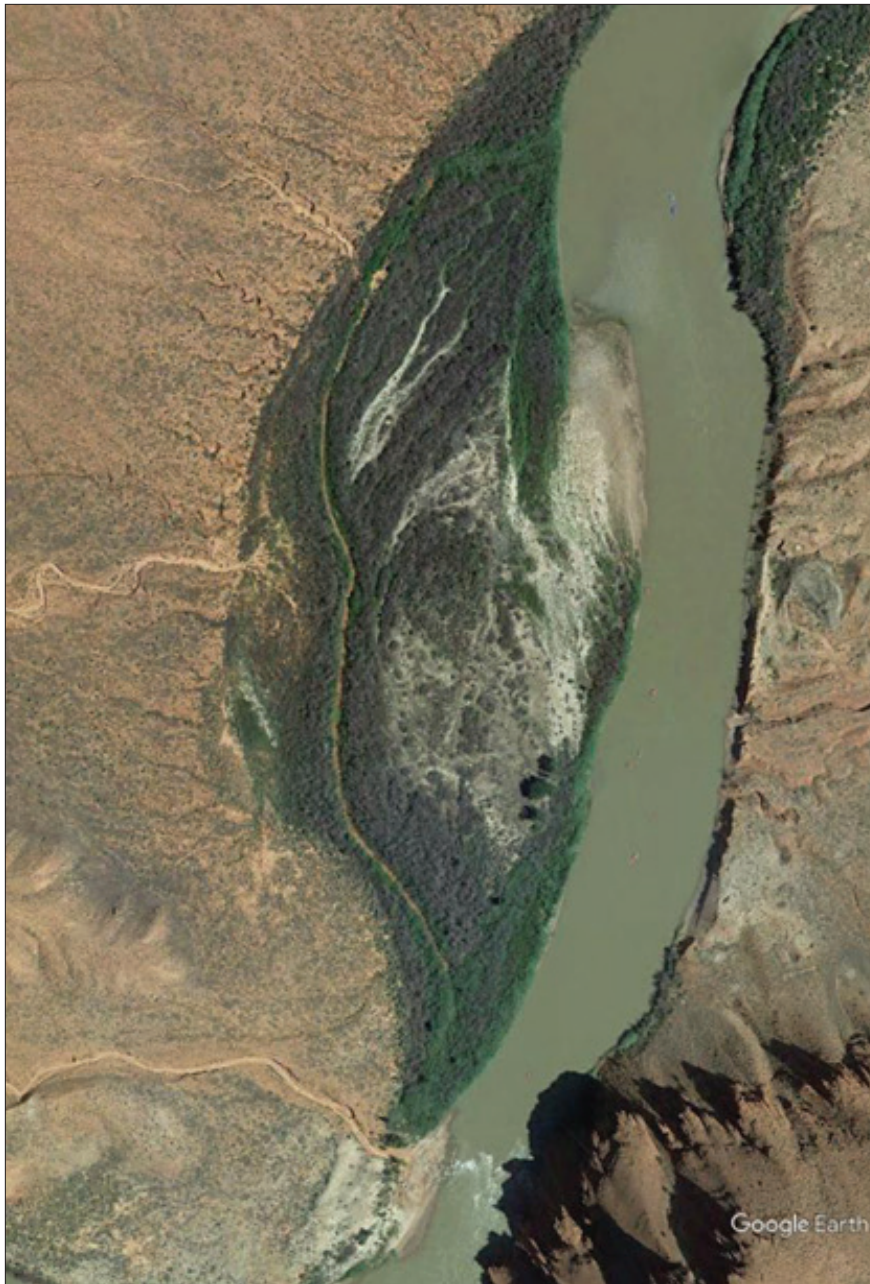
Figure 11. Above New Side Rapid Side Channel in July 27, 2015.

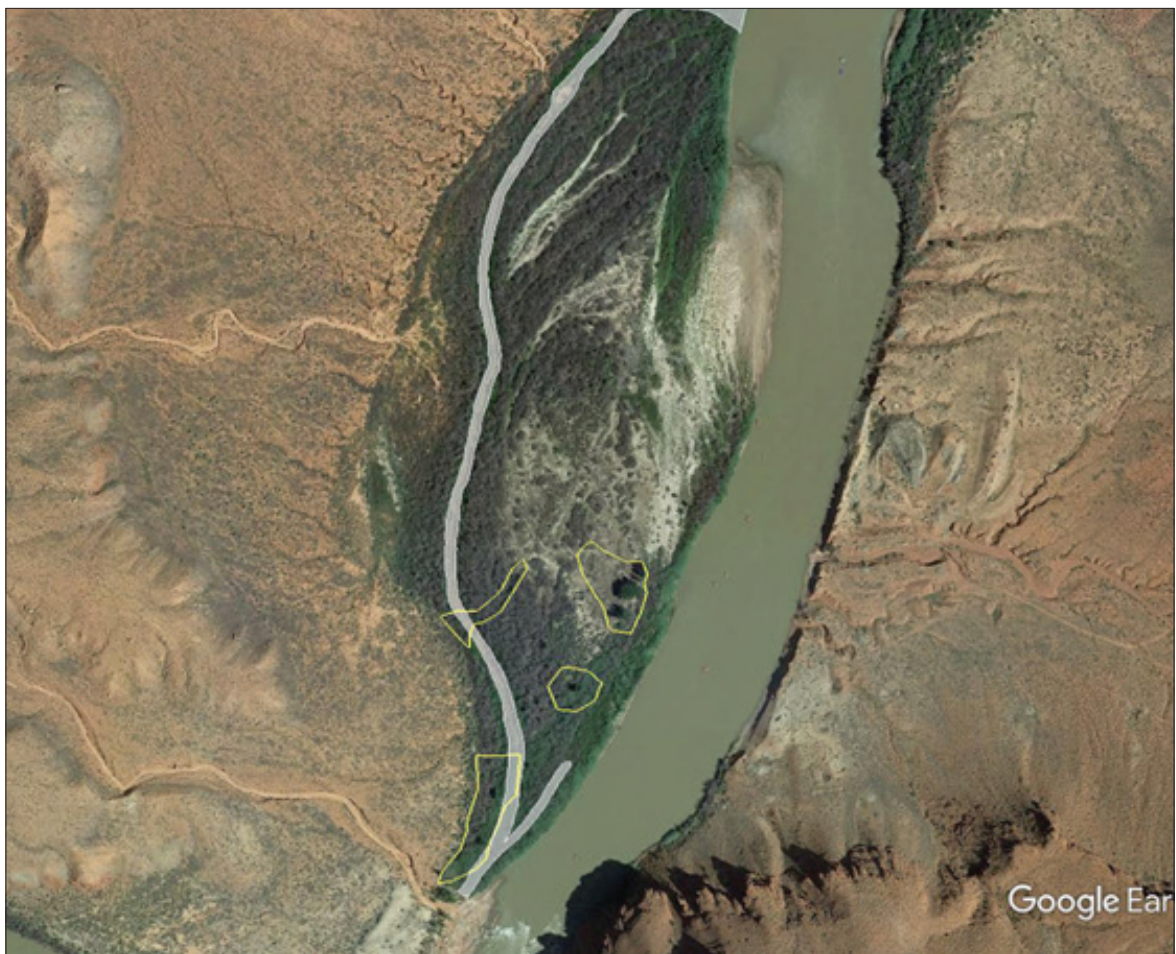
Since 2018, the main side channel and part of the secondary side channel have been cleared of tamarisk (Figures 12-14) and a buffer cleared around native cottonwoods (Figure 12). This work was funded through the Watershed Restoration Initiative (WRI) and completed by the Utah Conservation Corps (UCC) and Rim to Rim Restoration for the BLM Canyon Country Aquatic Habitats program. Future work will include clearing the smaller side channels and potentially streambank alteration to allow inundation at lower flows.

Figure 12. Completed work. White areas showed cleared side channel areas. Yellow shows areas cleared around native cottonwoods and shrubs.

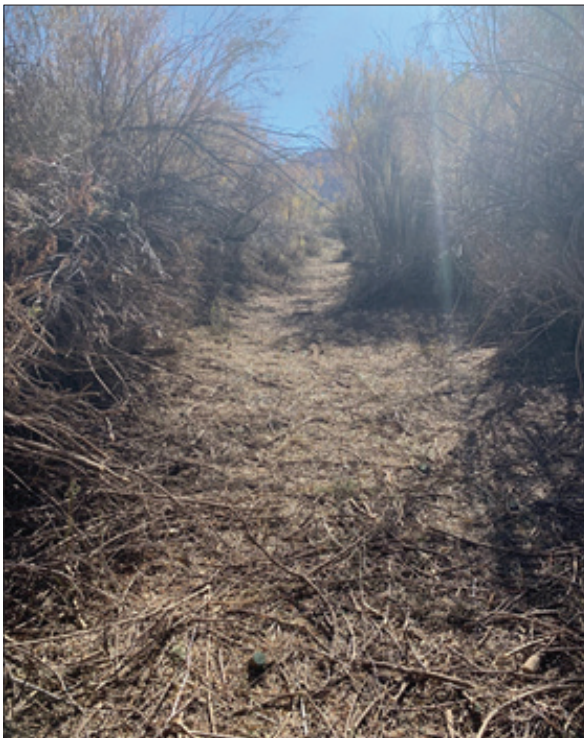
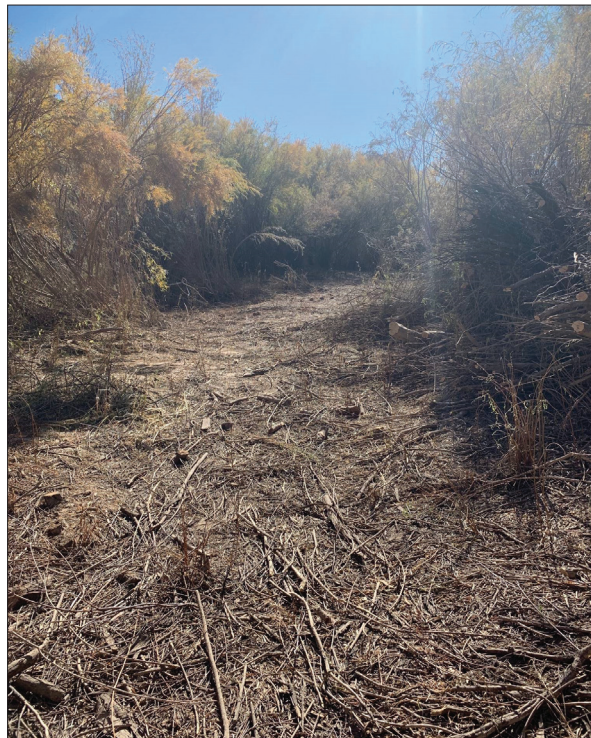
Figures 13 and 14. Side channel cleared of tamarisk.

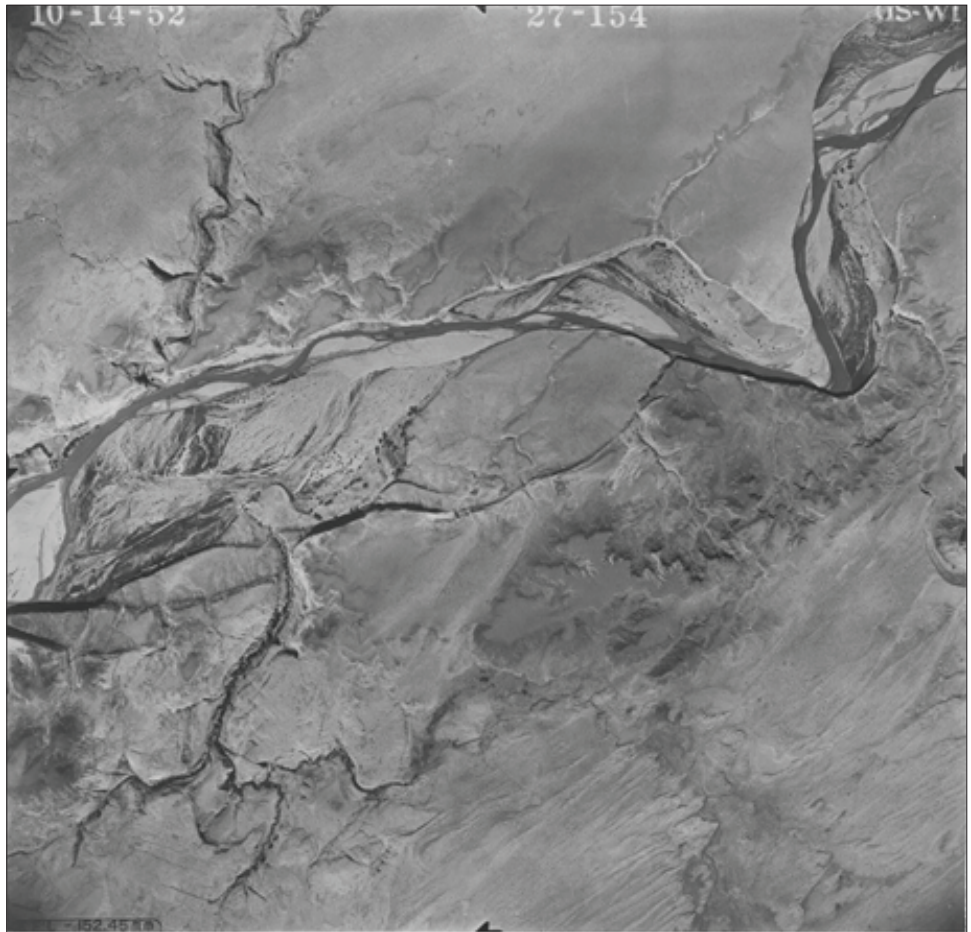
Figure 16. Historical Photo of Project Area in Oct. 14, 1952, note lack of vegetation encroachment on river channel.

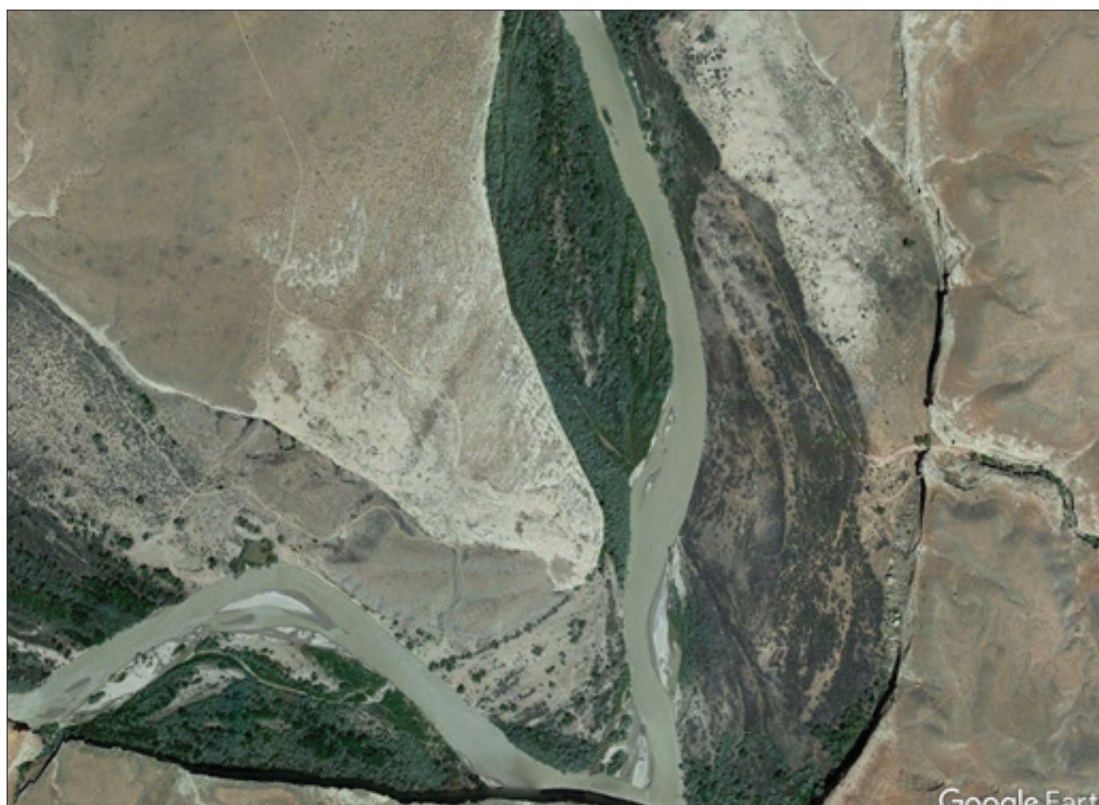
Figure 18. May 3, 2017 photo of project area showing channel narrowing and vegetation encroachment on the river channel.

The primary goal of this project is to remove Russian olive species within and adjacent to all side channel habitats so that natural hydrologic processes can be restored. High water scouring is more effective at naturally maintaining side channel habitat when the surface roughness and root systems associated with woody invasive species is removed. In the absence of woody invasive species, the current hydrology should support maintenance of these side channel habitats. Peak flows of ~7000 cfs have occurred in three of the last five years with peak flows reaching 11,000 cfs in 2019. The side channels and floodplains are connected at these flows. Another goal of this project is the protection of the cottonwood gallery and ultimately the restoration of the riparian vegetation community through the reduction of woody and herbaceous invasive species. Units 1 and 2 (Figure 15) have been treated with a frill cut method by the Canyon Country Youth Corps and the Utah Conservation Corps. This method provides for a very targeted application of herbicide while the tree is actively drawing resources from the canopy to the root system. Killing the root system is essential since they will resprout vigorously if only top-kill is achieved. Any living roots within the top 3-4 inches of soil can also resprout vigorously creating future treatments requiring less targeted herbicide applications. Once mortality of Russian olive is confirmed, and pending an Environmental Assessment (EA), a whole tree extraction methodology is desired to completely remove and pile the invasive trees in an area for future burning. Complete removal of Russian olive above and below ground biomass in and adjacent to side channels will allow these habitats to widen and reach equilibrium with the current flow regime.

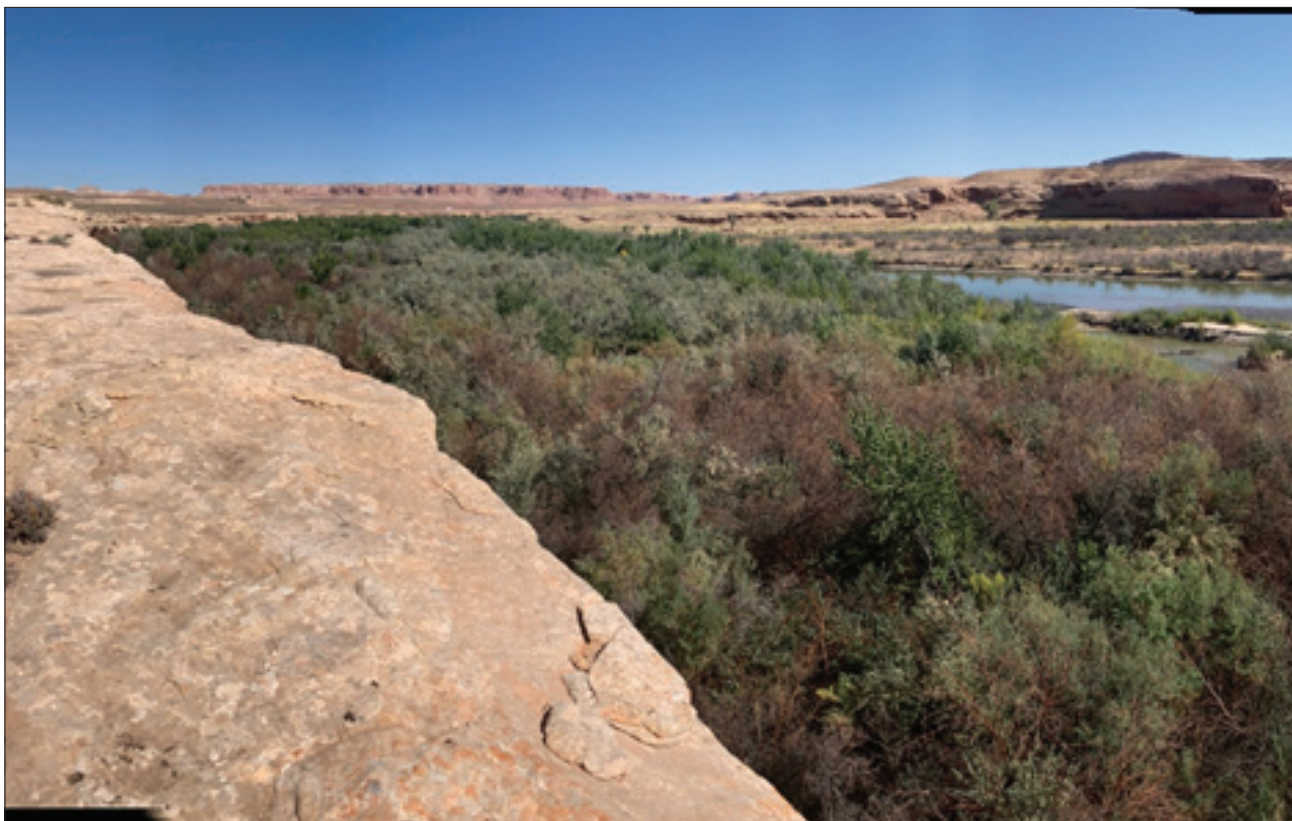
Figure 19. Senesced canopies of frill cut Russian olive along side channel (Oct. 2019).

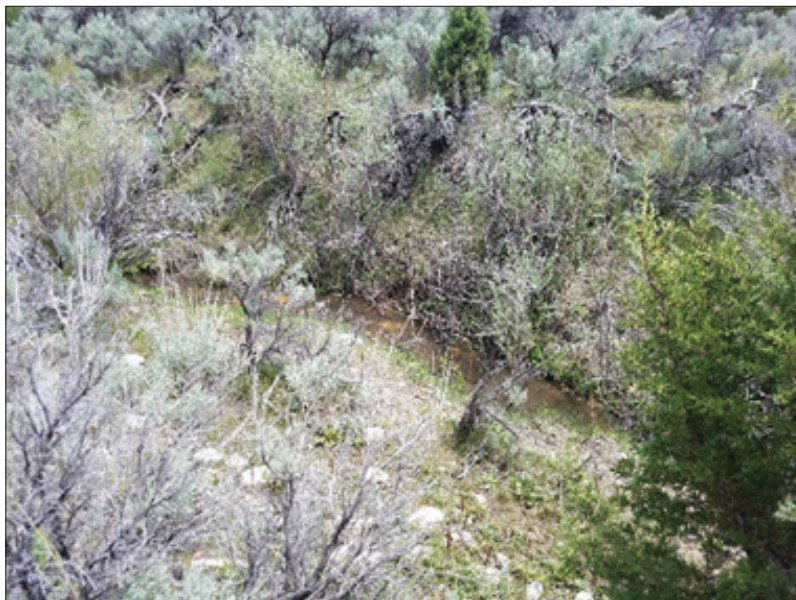
*Figure 21. Kimball Creek before structures -- note minimal riparian vegetation.*

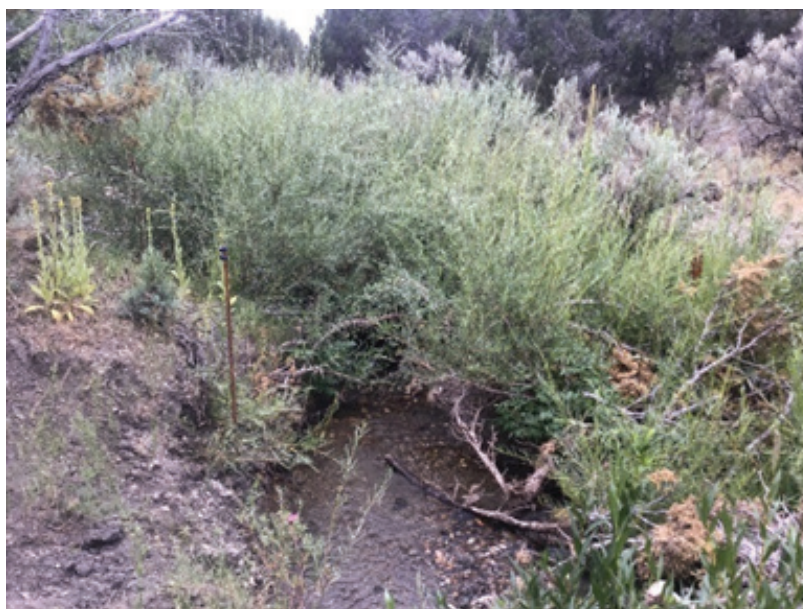
*Figure 22. Kimball Creek after structures -- note dead junipers from structure and willow recruitment covering majority of structure.*

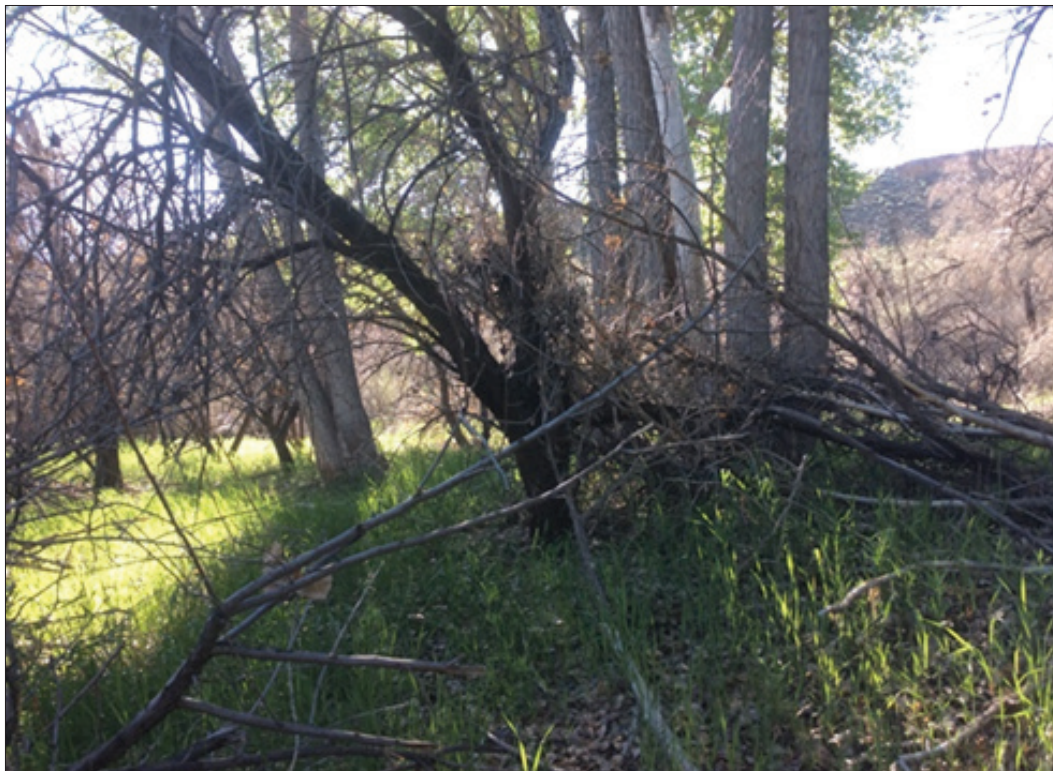
*Figure 29. Before: Non-native tamarisk and Russian Olive on native cottonwood stands along the White River riparian corridor.*

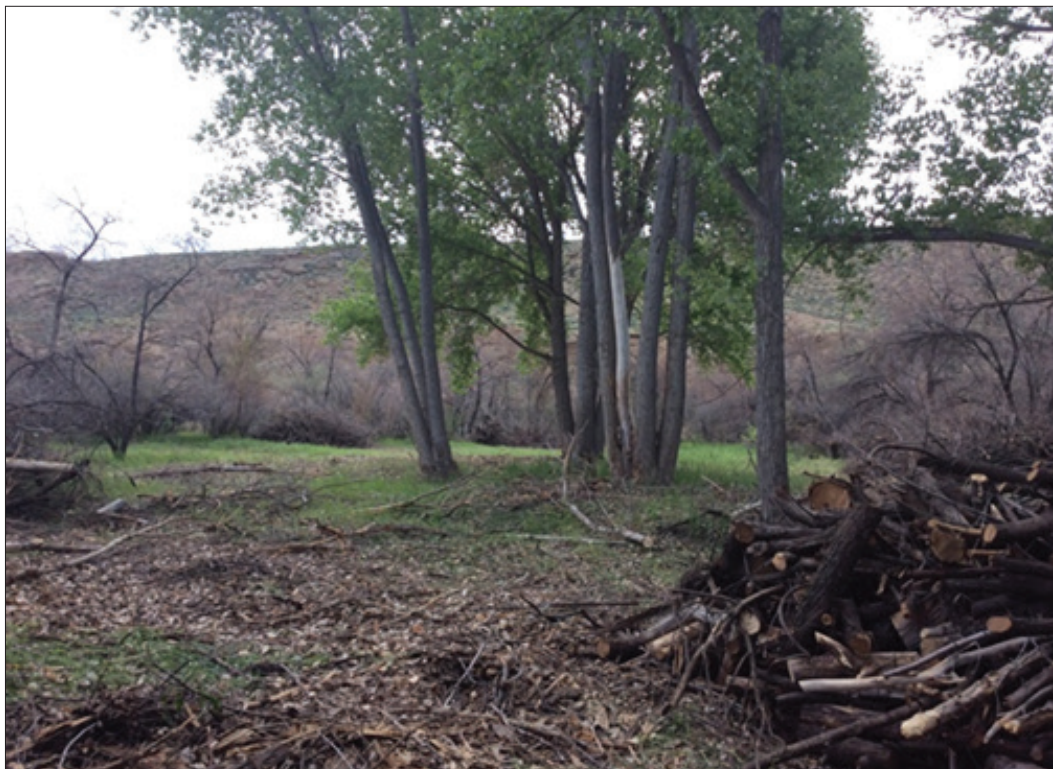
*Figure 30. After: Non-native tamarisk removed from native cottonwood stands along the White River riparian corridor.*

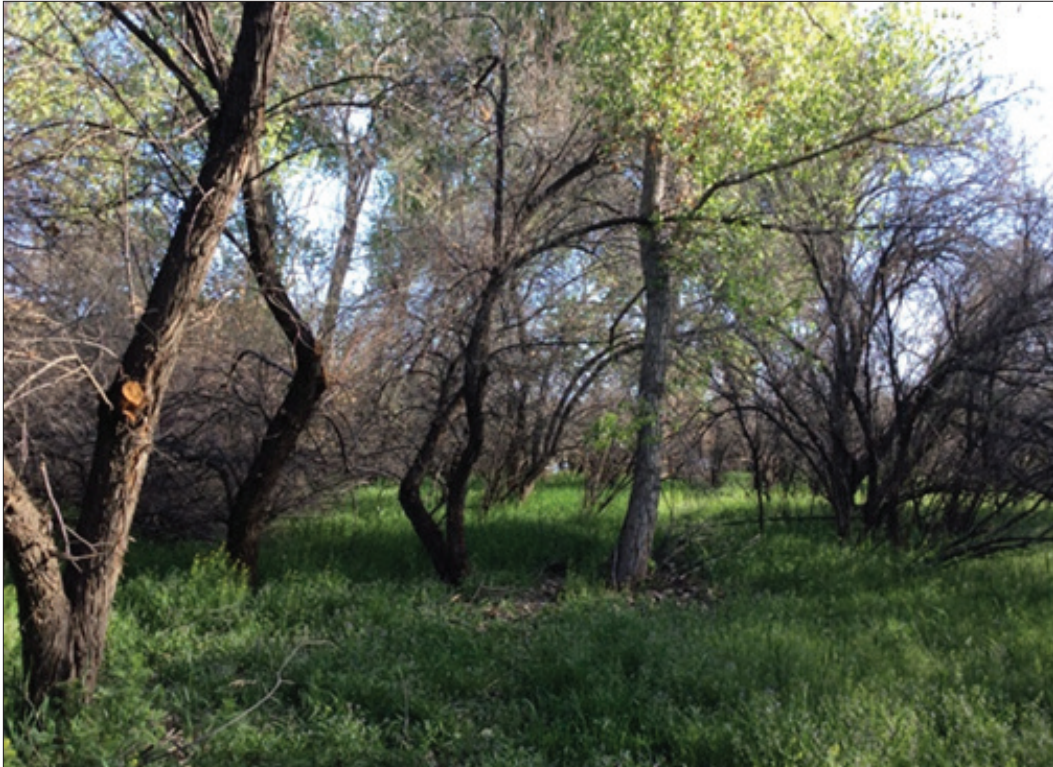
*Figure 31. Before: Non-native tamarisk and Russian Olive on native cottonwood stands along the White River riparian corridor.*

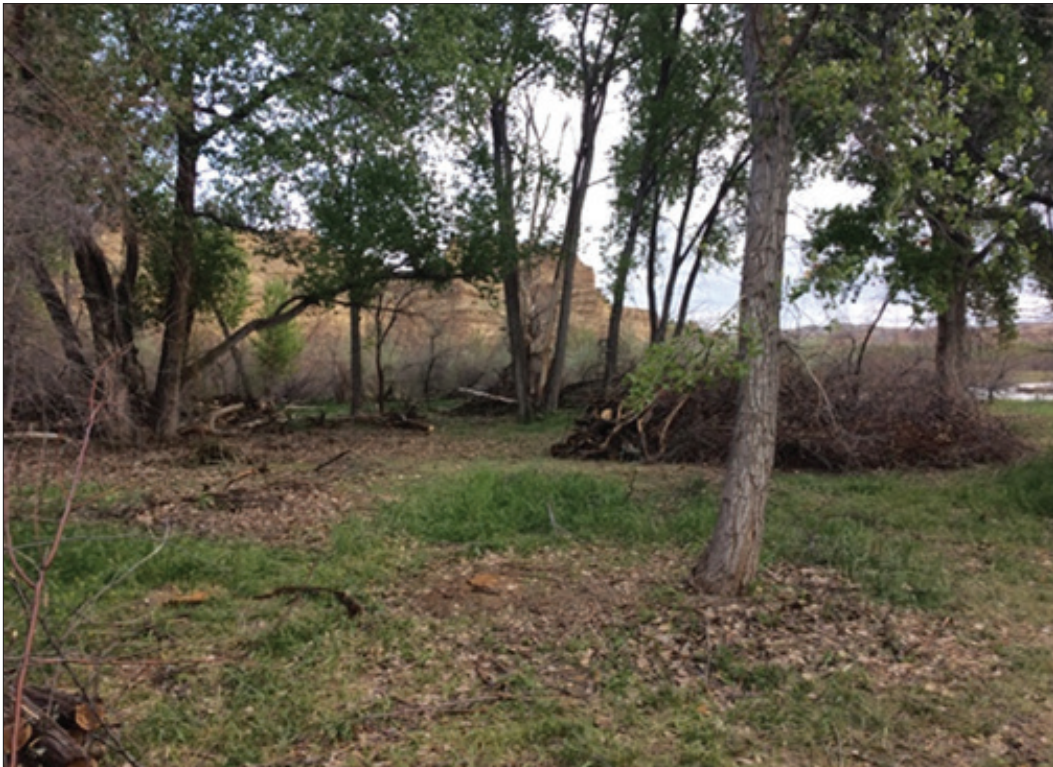
*Figure 32. After: Non-native tamarisk removed from native cottonwood stands along the White River riparian corridor.*
